DUTCH HOLLOW DAM BREAK ANALYSIS 2021 MAP REVISION

LOT 1, C.S.M. NO 705  
TOWN OF LAVALLE  
SAUK COUNTY, WISCONSIN

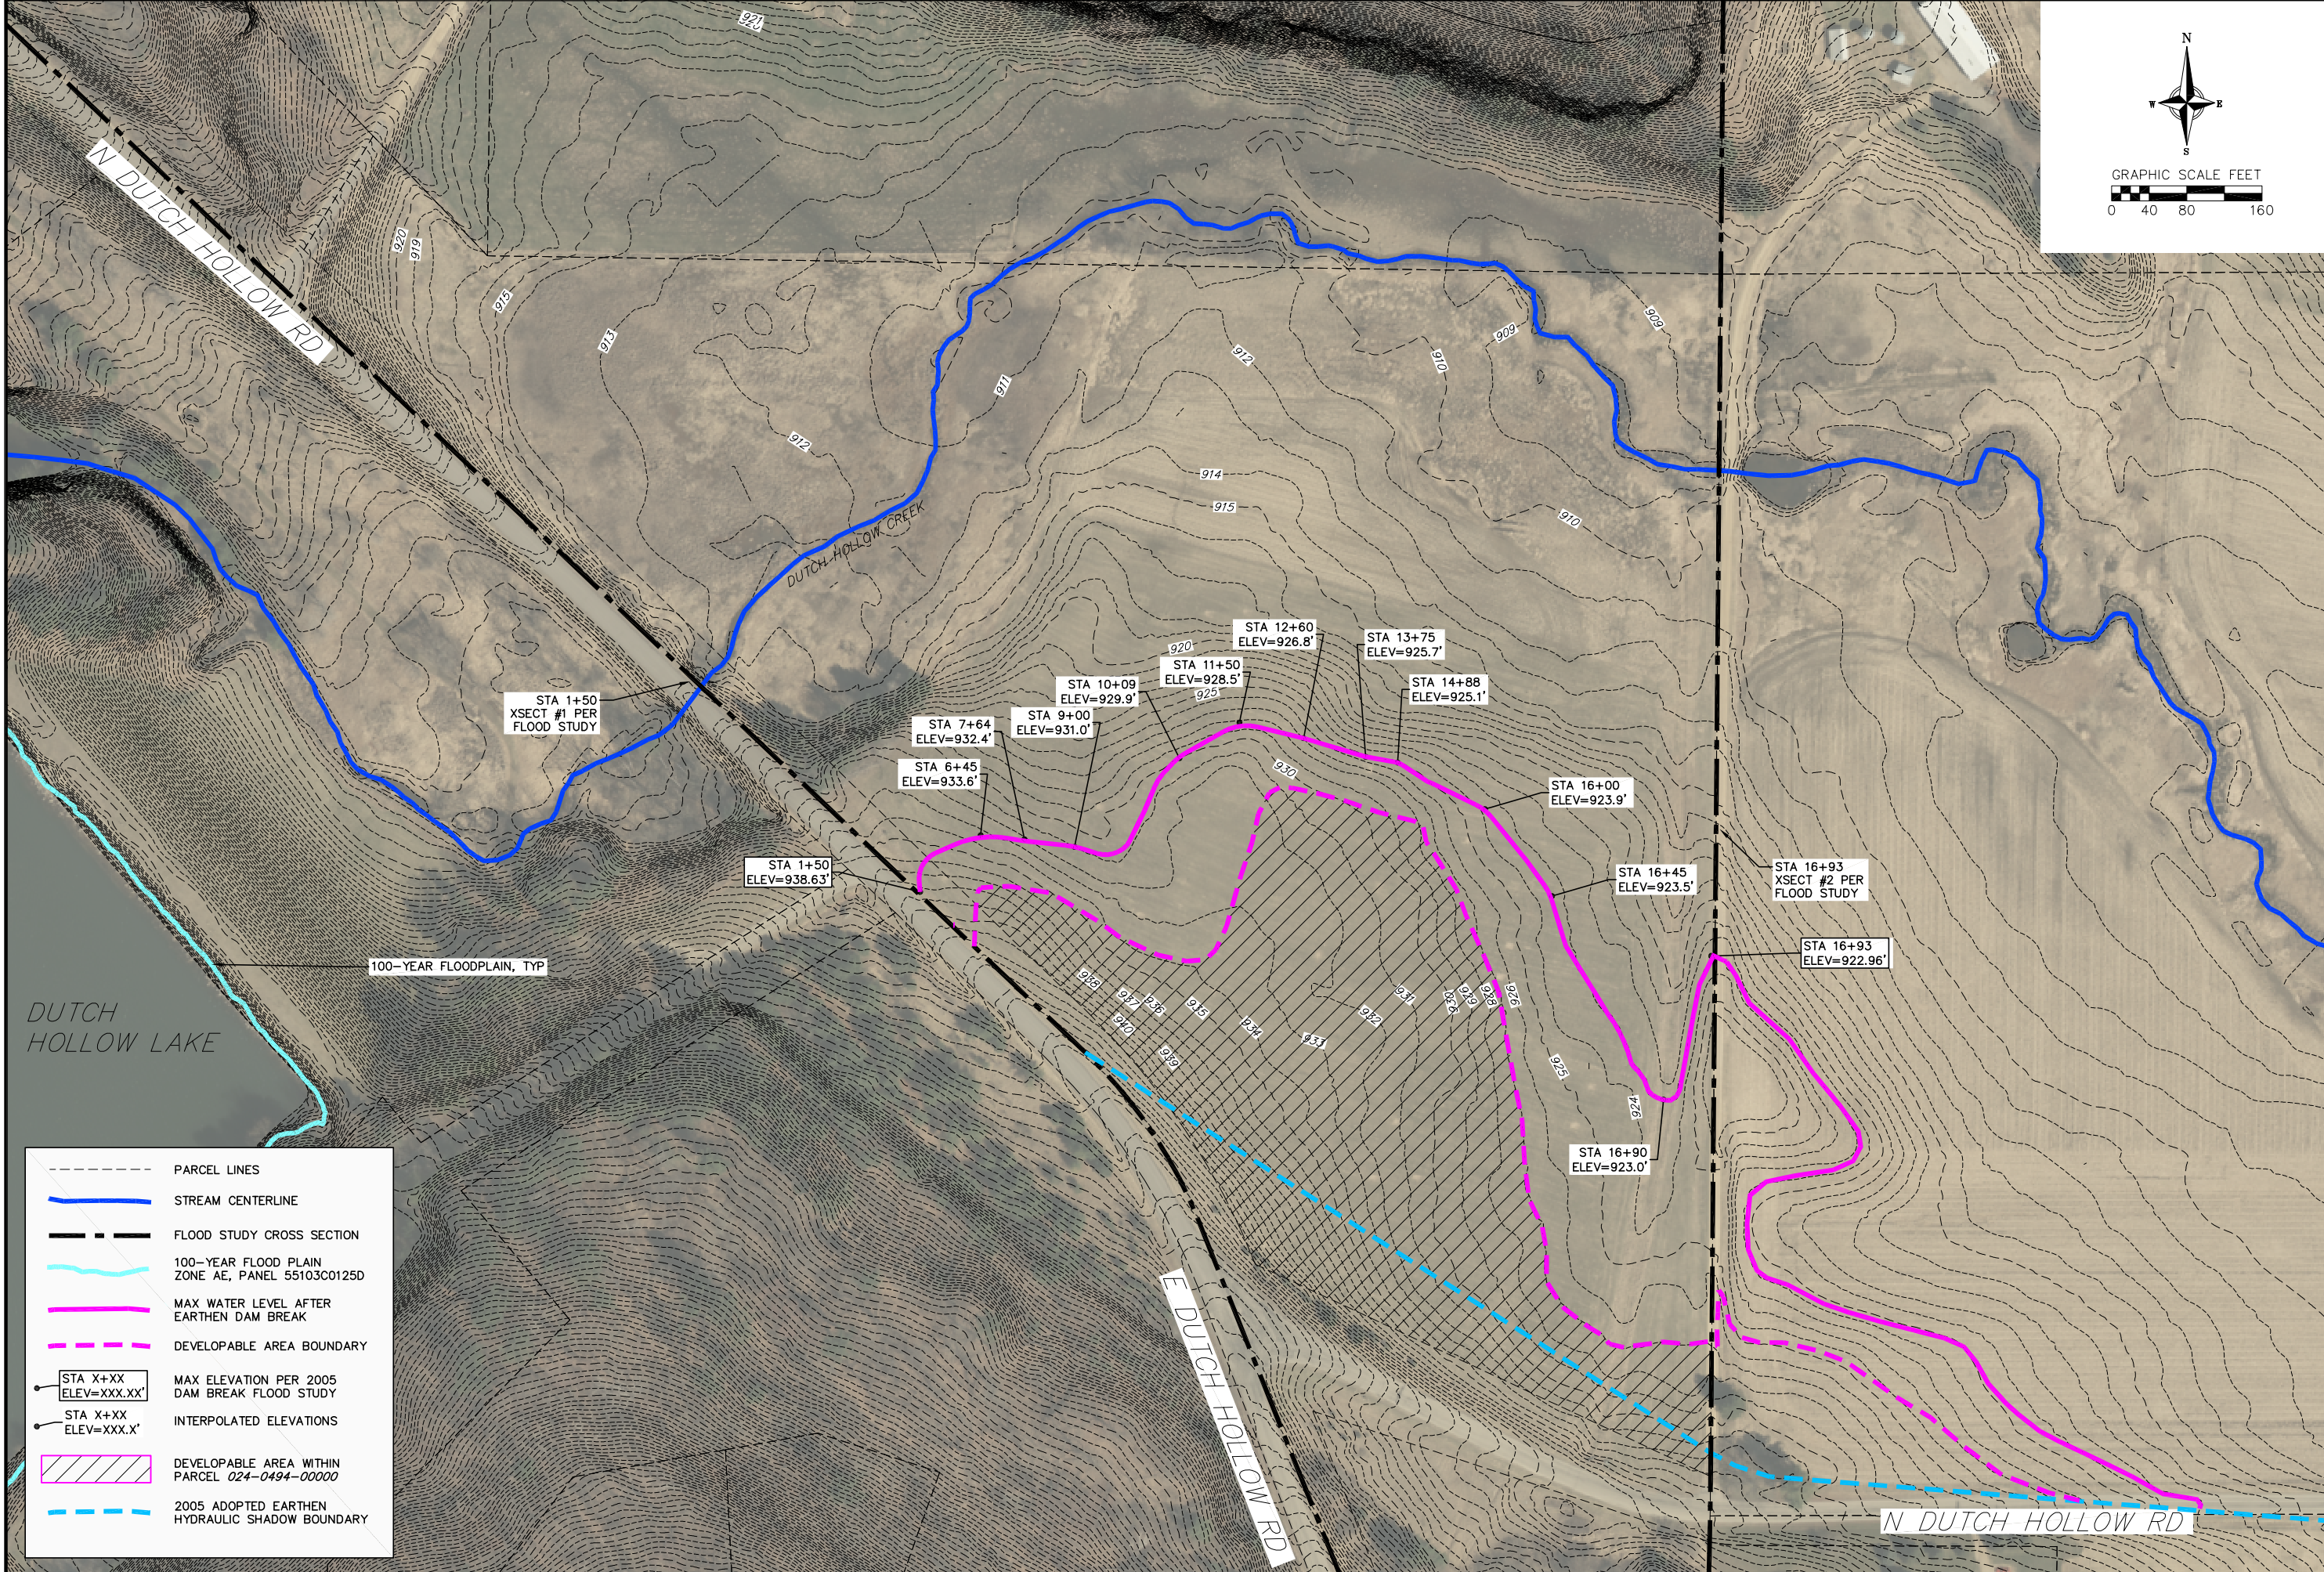
1 OF 1

FLOOD STUDY CROSS SECTION

100-YEAR FLOOD PLAIN  
ZONE AE, PANEL 55103C0125D

MAX WATER LEVEL AFTER  
EARTHEN DAM BREAK

DEVELOPABLE AREA BOUNDARY

MAX ELEVATION PER 2005  
DAM BREAK FLOOD STUDY

INTERPOLATED ELEVATIONS

DEVELOPABLE AREA WITHIN  
PARCEL 024-0494-00000

2005 ADOPTED EARTHEN  
HYDRAULIC SHADOW BOUNDARY
